**Flood Control Project Maintenance  
Levee Inspections****LMA District Cover Sheet****Spring 2012 Levee Inspection Results****Sutter Maintenance Yard East Levee Sutter Bypass**

**Spring 2012 Levee Inspection Results**

**Sutter Maintenance Yard East Levee Sutter Bypass**

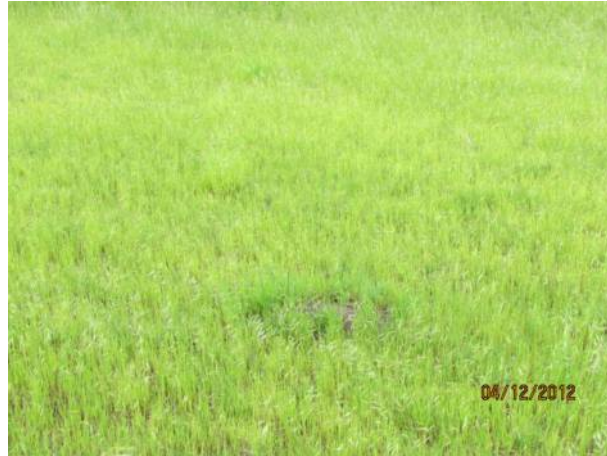
Levee Mile Report Line	4
Start Levee Mile	3.84
End Levee Mile	3.84
Location	Water Side
Category	Earthen Levee
Item	Animal Control

View of the grouted rodent hole.

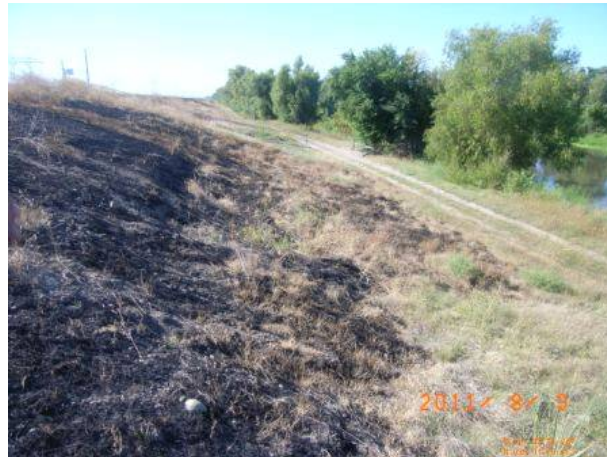
Levee Mile Report Line	5
Start Levee Mile	10.98
End Levee Mile	11.05
Location	Water Side
Category	Supplemental
Item	USACE Erosion Survey

USACE 2011 Photo #1

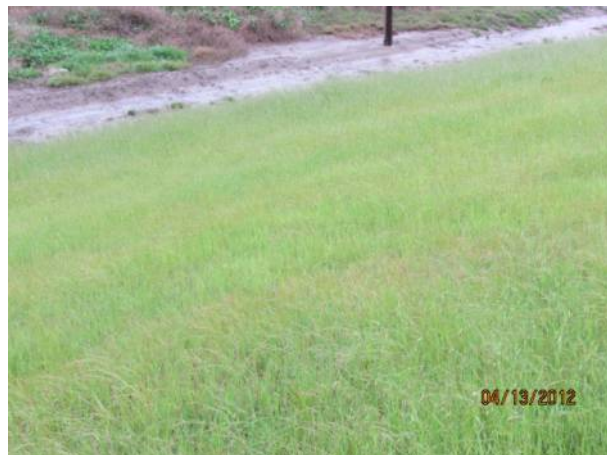
Levee Mile Report Line	6
Start Levee Mile	16.40
End Levee Mile	16.40
Location	Land Side
Category	Earthen Levee
Item	Animal Control

View of the grouted rodent hole.

DWR ID: DWR_ST0002_01_s_2012_1		
6	16.40	16.40	Earthen Levee	Animal Control	LS	A Ma	A1 : Exterminate rodents and backfill and compact or grout burrows.	38.965675 ° -121.670967 °	38.965675 ° -121.670967 °	325 Y	
									DWR ID: DWR_ST0002_01_s_2012_325		
7	16.59	16.59	Earthen Levee	Animal Control	LS	A Ma	A3 : No rodents visible, but rodent burrows visible; need to backfill and compact or grout burrows.	38.963578 ° -121.668533 °	38.963578 ° -121.668533 °	326 Y	
									DWR ID: DWR_ST0002_01_s_2012_326		
8	20.64	20.64	Earthen Levee	Encroachments	LS	U En	BU : Buildings	38.918147 ° -121.624545 °	38.918147 ° -121.624545 °	10 Y	
									DWR ID: DWR_ST0002_01_s_2012_10		
9	20.91	20.91	Earthen Levee	Animal Control	LS	M Ma	A3 : No rodents visible, but rodent burrows visible; need to backfill and compact or grout burrows.	38.914568 ° -121.623260 °	38.914568 ° -121.623260 °	327 Y	
DWR ID: DWR_ST0002_01_s_2012_327

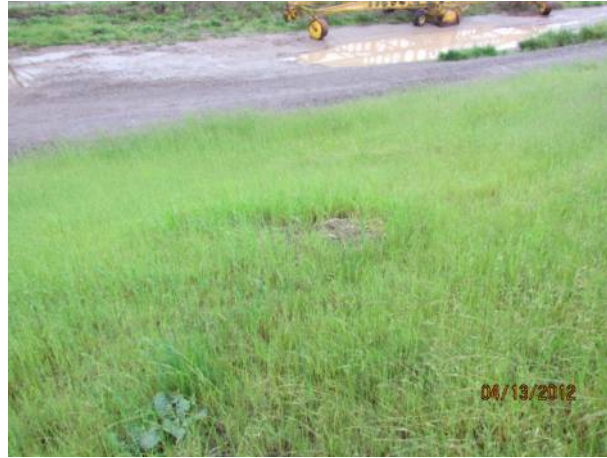
Levee Mile Report Line	7
Start Levee Mile	16.59
End Levee Mile	16.59
Location	Land Side
Category	Earthen Levee
Item	Animal Control

View of the grouted rodent hole.

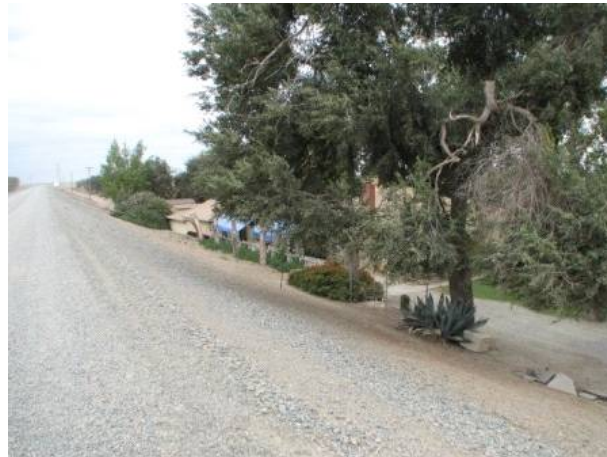
Levee Mile Report Line	8
Start Levee Mile	20.64
End Levee Mile	20.64
Location	Land Side
Category	Earthen Levee
Item	Encroachments

View of the building next to the landside toe of the levee.
